ROCKFALL PROTECTION TO DUDLEY WARD TUNNEL, NORTHERN APPROACH, GIBRALTAR

S.W. LIGHTBODY

Golder Associates (UK) Ltd, Sirius Building, The Clocktower, South Gyle Crescent, Edinburgh, EH12 9LB, UK.

Lightbody, S.W. 2015. Rockfall protection to Dudley Ward Tunnel, Northern Approach, Gibraltar. Pp 146-157 in Hunger, E. and Brown, T.J. (Eds.) Proceedings of the 18th Extractive Industry Geology Conference 2014 and technical meeting 2015, EIG Conferences Ltd. 250pp. email: slightbody@golder.com

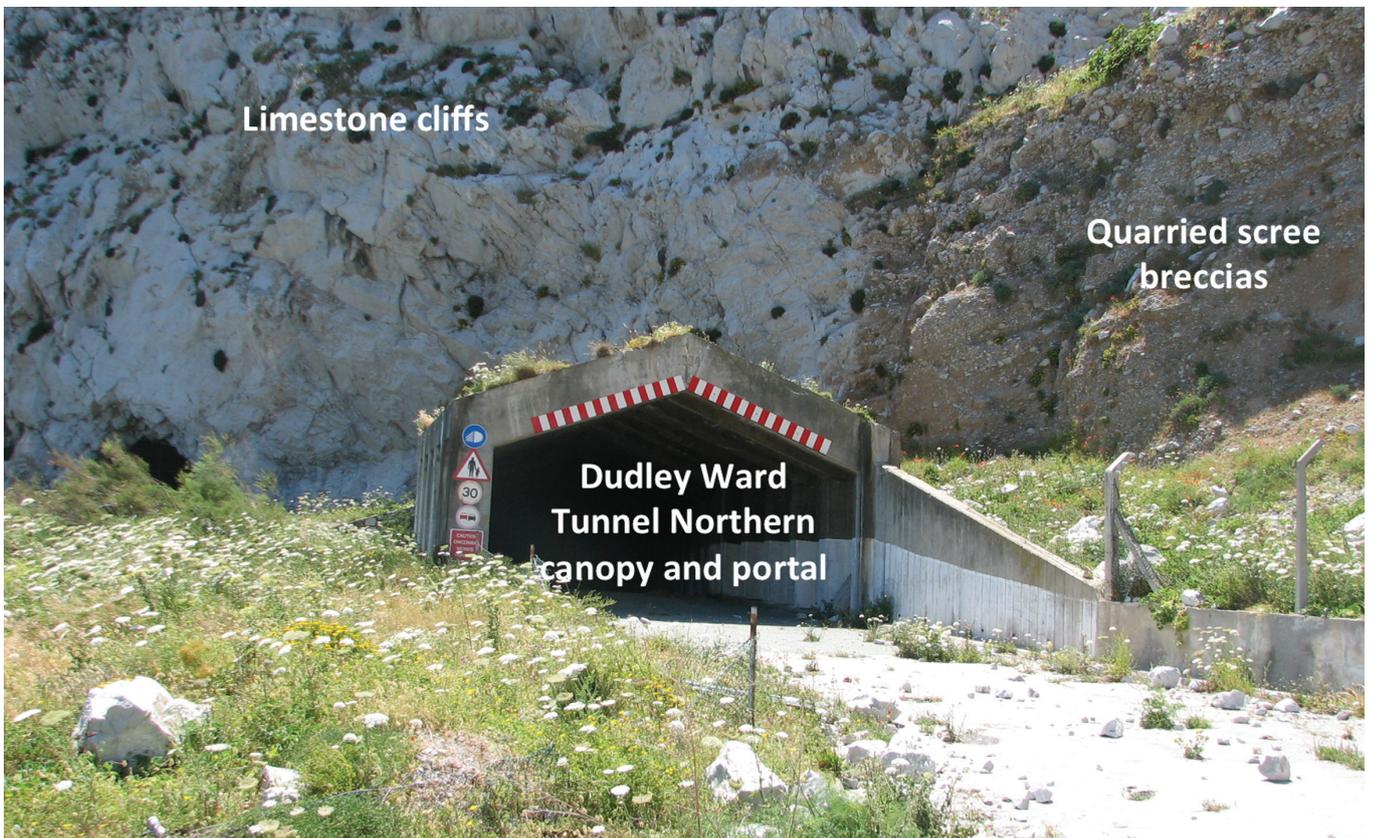
Figure 4. Original Dudley Ward Northern Approach tunnel portal.

The Old Dudley Ward Tunnel Approach Road took a sharp bend around an old tank farm (Figures 2 and 3) and at this point was over 5m above the original floor level of the tank farm. The road then entered the 720m long unlined Dudley Ward Rock Tunnel through a short concrete rock fall shelter (Figure 4).

The Dudley Ward area is dominated by the presence of scree breccias with a steeply angled front face beneath the massive Gibraltar Limestone cliffs above, see Figures 3 and 4. The highest point on the Rock is situated directly above Dudley Ward.

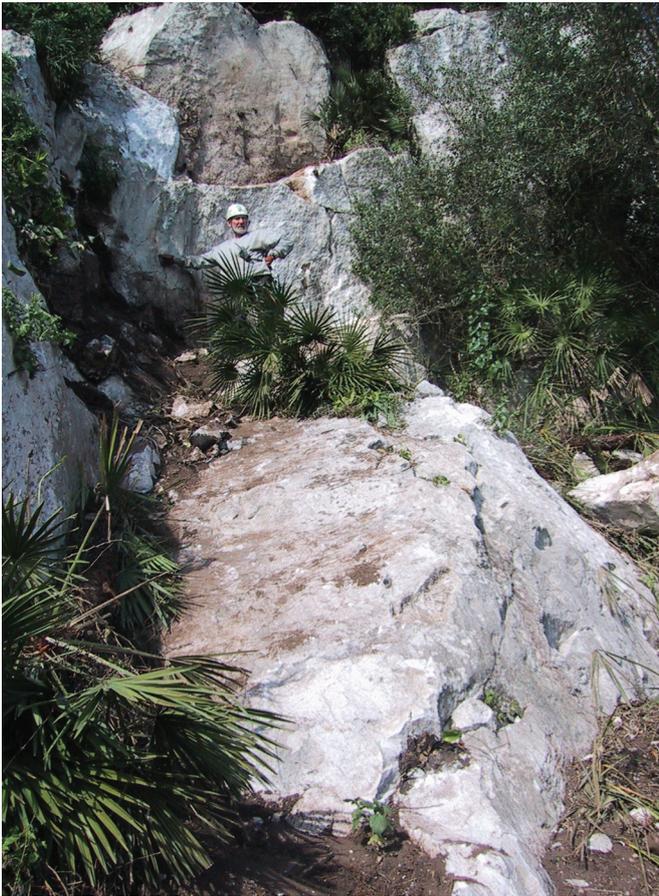
Figure 5. Location of the failed seeder block involved in the 2002 rockfall incident.

- the rock fall originated from over 300m above the road as a 100t block which fragmented into smaller blocks as it impacted on the cliff face and scree breccia slopes below (Figure 5);

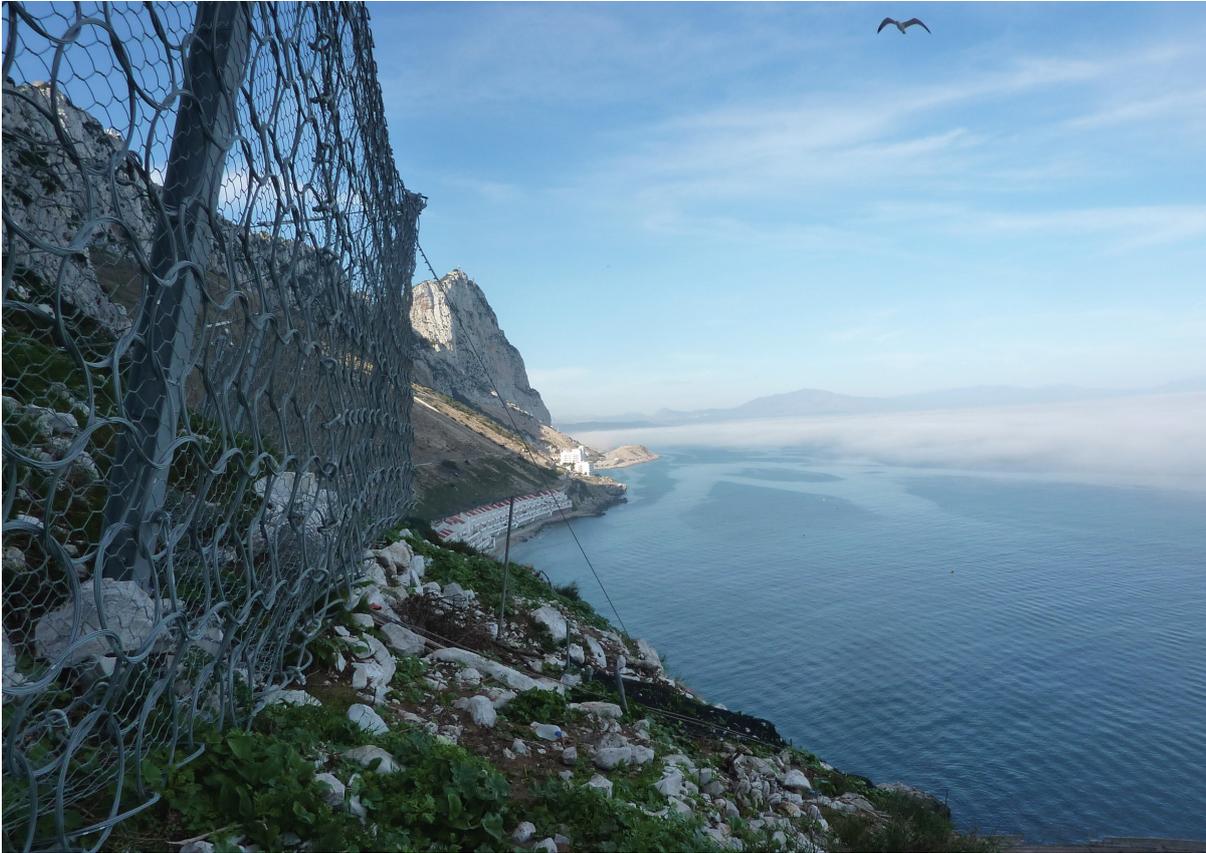
Figure 8. Completed rockfall catch fences. View looking north to Sandy Bay, Catalan Bay and the North Face.

The superstructure was transported to the slopes using a helicopter. The catch fences were completed in September 2009 (Figure 8). The catch fences successfully retained a large rock fall at the northern end of the Site during the canopy construction. The catch fence was repaired and continues to provide the primary line of rock fall protection to the highway.

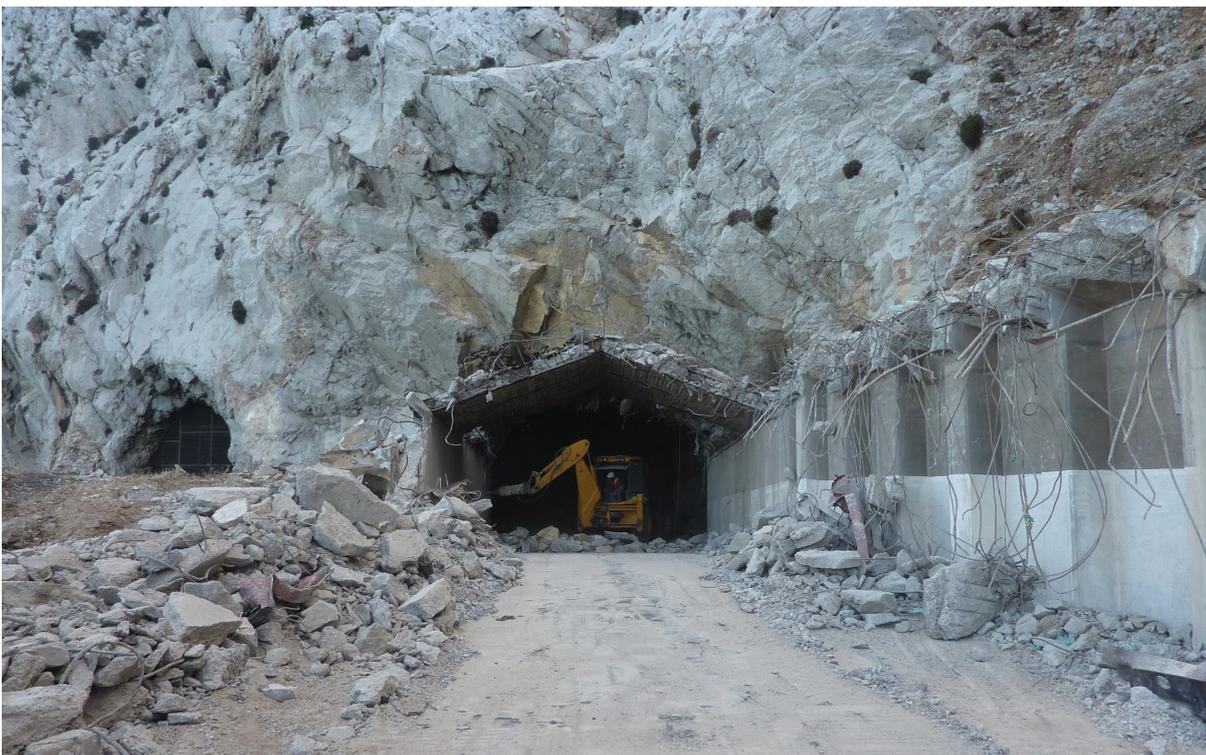
Figure 9. Demolition of the Dudley Ward Northern Approach old rock fall canopy.

The advanced earthworks contract commenced in July 2009 and was completed in December 2009. This included screening and crushing of existing building waste and the demolition of existing structures along the new road alignment, including the old rock fall canopy structure (Figure 9).

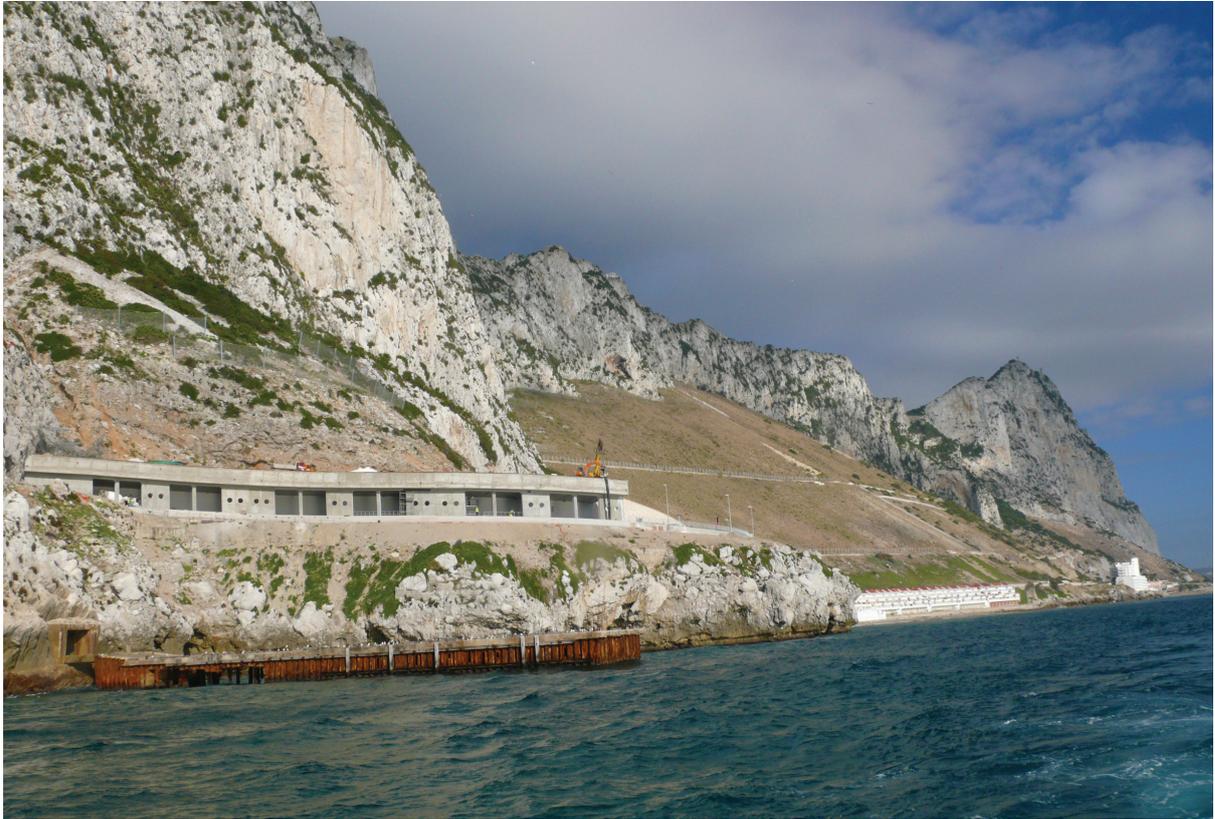
Figure 10. The completed 100m long rockfall canopy. Rock fall catch fences visible above the canopy. View looking northwest.

The rock fall canopy construction and associated highway improvements commenced in January 2010 and were completed on 1st November 2010 (Figures 10 and 11). This was a particularly challenging phase of the project as the January 2010 to April 2010 period was the wettest since records began, meaning that the works had to be carried out under significant rock fall risk

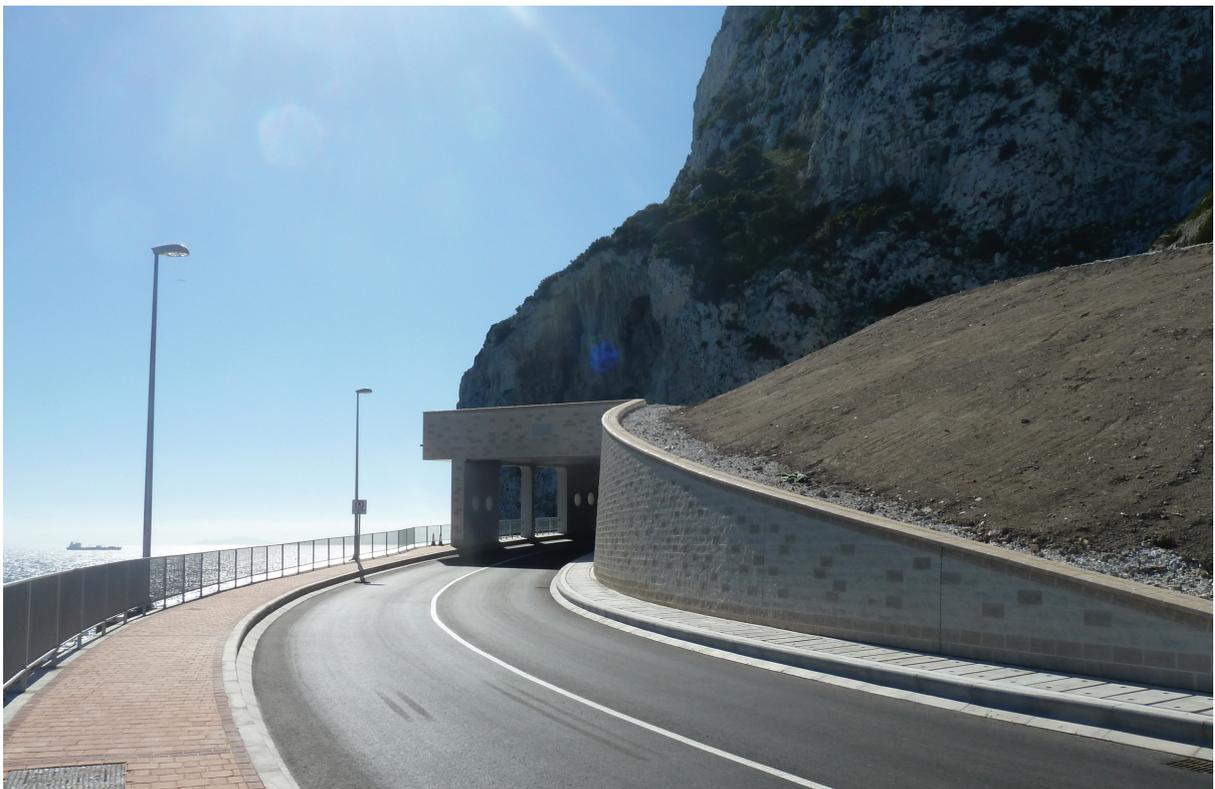
Figure 11. The completed rock fall canopy, counterfort retaining wall, rock fall catch ditch and approach road.
